NTR708

VEHICLE APPLICATION

DOUBLE DIN INSTALLATION INSTRUCTIONS

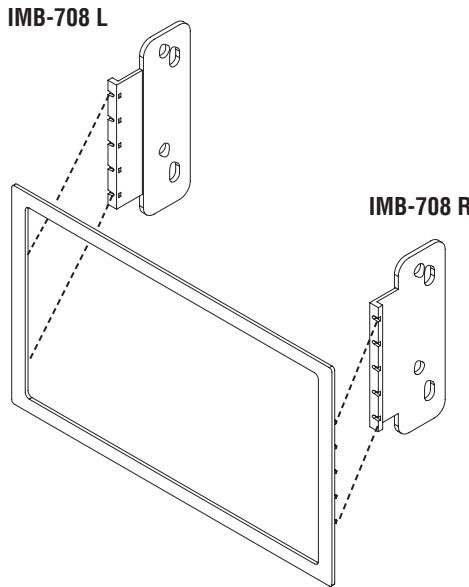
Figure A

1. Attach the Left and Right brackets to the main NTR708. As shown in fig A.
2. Attach the factory metal mounting brackets to the left and right rear sides of the Double Din radio using 2 of the screws removed from the factory radio.
3. Align the left and right NTR708 brackets to the appropriate sides of the aftermarket radio and attach using the remaining 2 screws supplied with radio when possible.
